PROPERTY CONDITION ASSESSMENT

SpringHill Suites Phoenix West
9950 West Encanto Boulevard
Avondale, Arizona 85392

June 4, 2025

REFERENCE: GRE-034-25
WWW.GABIONREA.COM

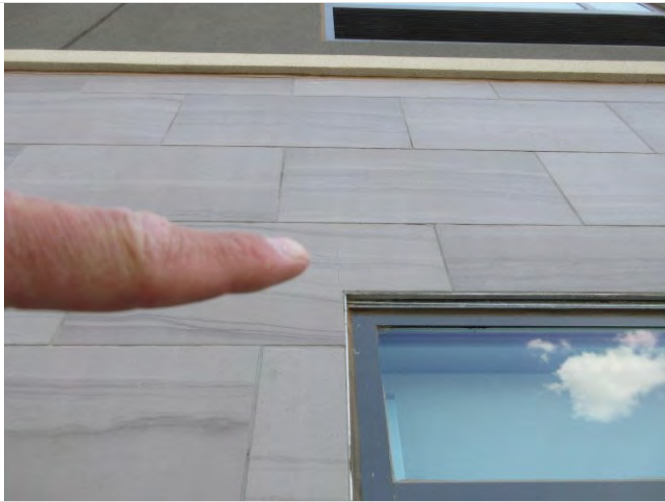
We identified a cracked exterior tile on the west elevation. Consideration should be given to replacing the tile to maintain the appearance of the property.

51. Cracked exterior tile

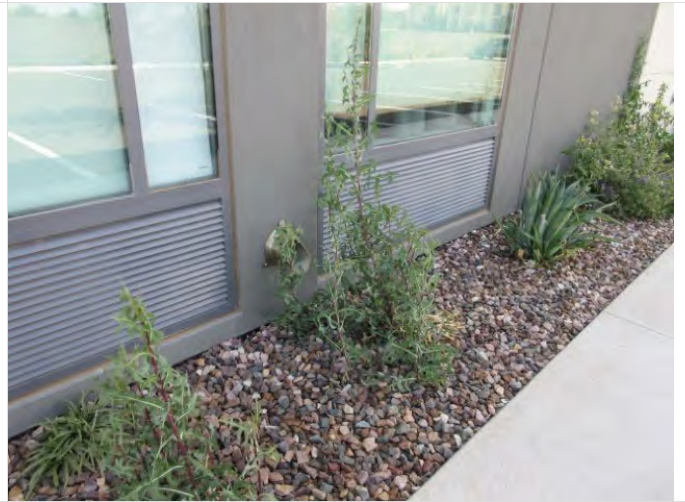
Landscaping was identified as attractive and in fair condition; however, we identified a damaged tree adjacent to the west property line and areas of weed growth adjacent to the west building elevation. Management reported that the Property does not have a landscape maintenance contractor and all work is currently completed by their Maintenance Supervisor. Consideration should be given to hiring a landscape maintenance contractor to maintain the Property and replace the damaged tree. Accordingly, we have included an allowance for replacing the damaged tree and removing weeds in Year 1 of the Capital Schedule. Future landscape maintenance should be handled as an operational expense.

52. Overgrown weeds on east elevation

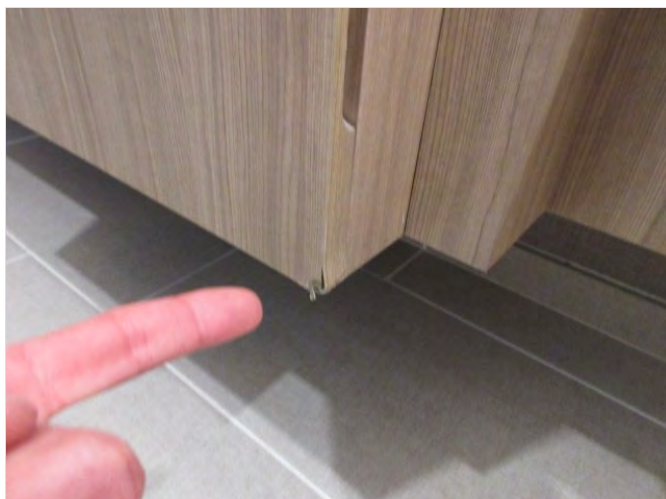
We identified that nearly all guestroom cabinets showed corner damage on the removable doors covering the sink drains. According to Management, these doors are a standard brand design equipped with friction cabinet catches and no hinge hardware, which has led to accidental drops when guests mistakenly assume the panels are hinged. To prevent ongoing damage and preserve cabinet appearance, consideration should be given to adding hinges to secure the doors in place. Accordingly, we have included an allowance for this work in Year 1 of the Capital Schedule.

73. Damage at cabinet door

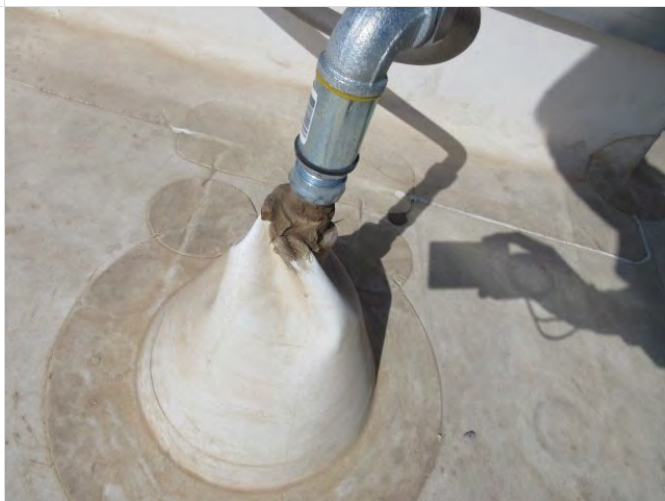
88. Collapsed roof penetration boot

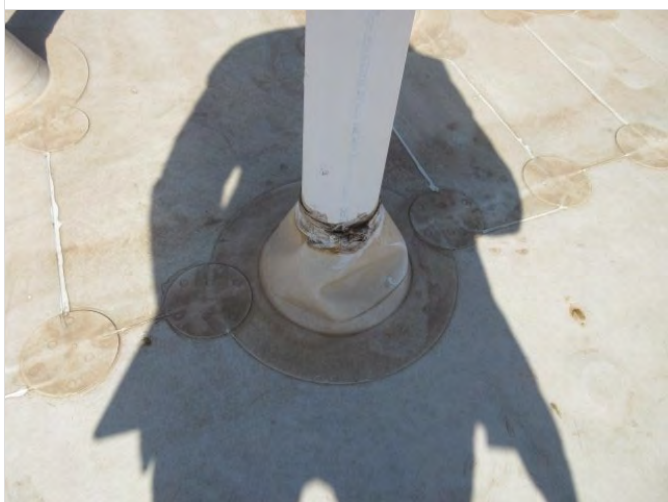
89. Collapsed roof penetration boot

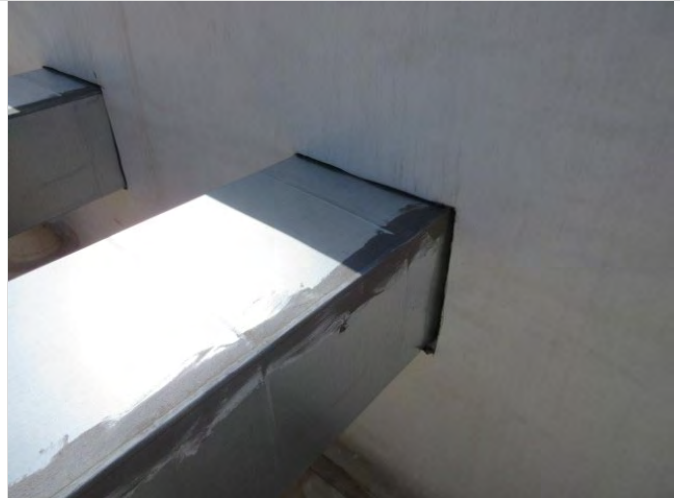
92. Ducting from package unit to elevator shaft, missing flashing

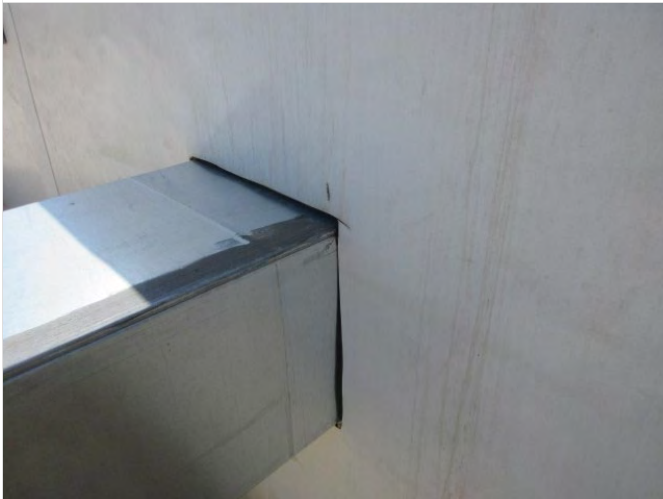
93. Missing flashing

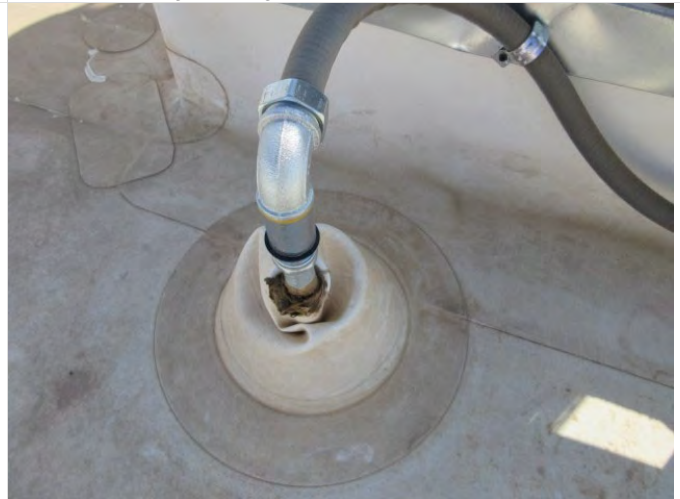
94. Collapsed boot

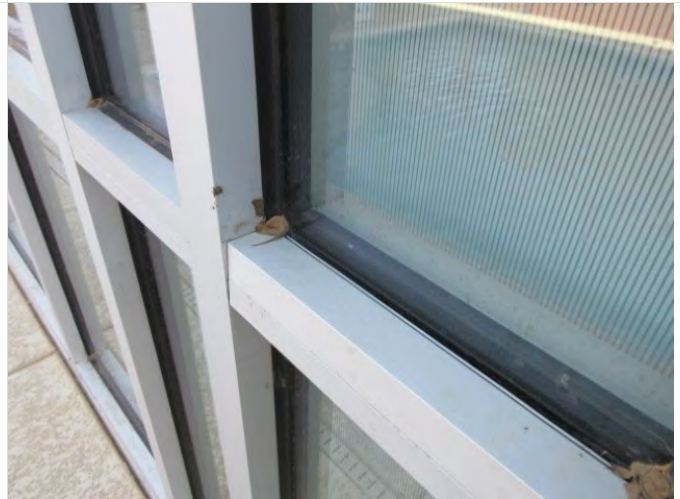
Several windows and frames were found to be dirty, with excessive sealant on the corners and adhesive residue on the glazing. Consideration should be given to cleaning the glazing and frames to improve their appearance. Although this appears to be a remnant of construction that should have been addressed as a punch list item, we have included an allowance for this work in Year 1 of the Capital Schedule.

100. Excessive caulking at storefront windows adjacent to pool
