PROPERTY CONDITION ASSESSMENT

SpringHill Suites Phoenix West
9950 West Encanto Boulevard
Avondale, Arizona 85392

June 4, 2025

REFERENCE: GRE-034-25
WWW.GABIONREA.COM

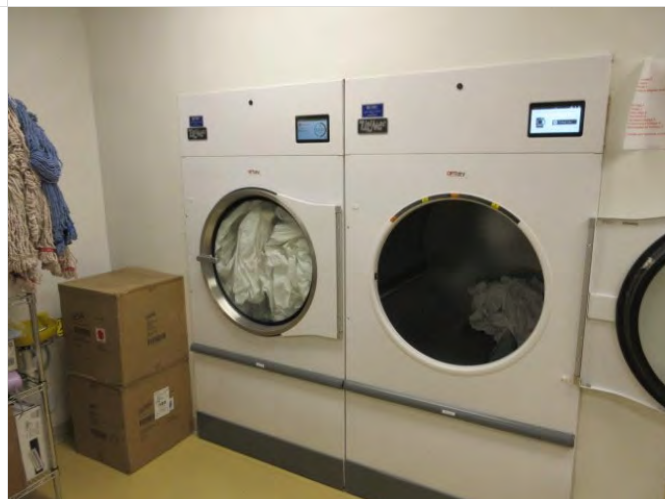
40. Commercial dryers

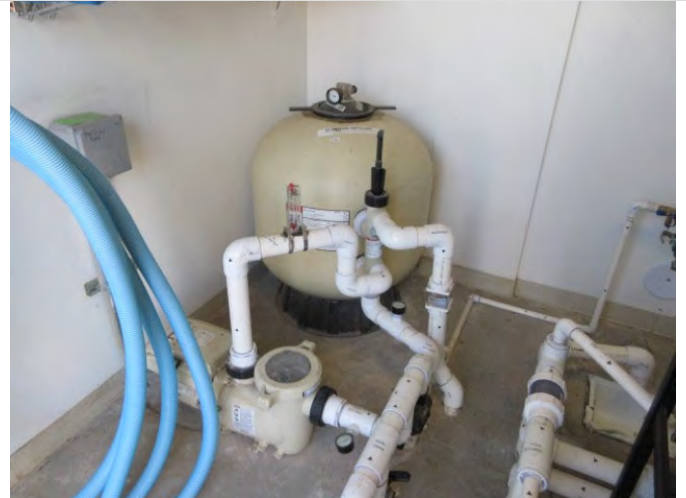
44. Pool sand filter

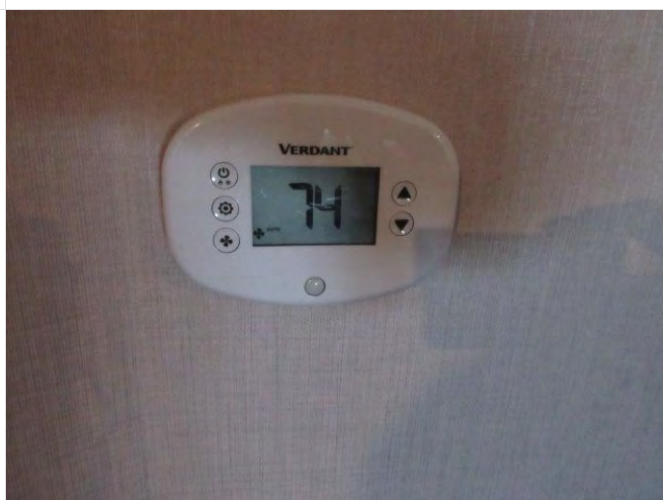
78. Guestroom verdant thermostat

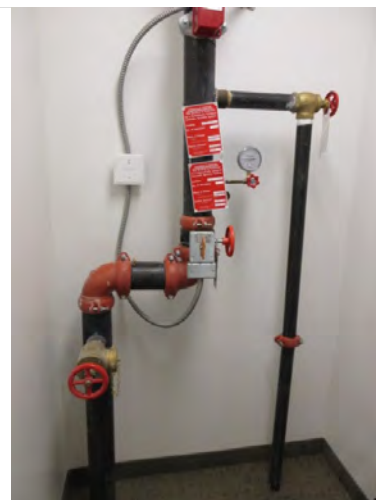
84. Fire riser in stairwell

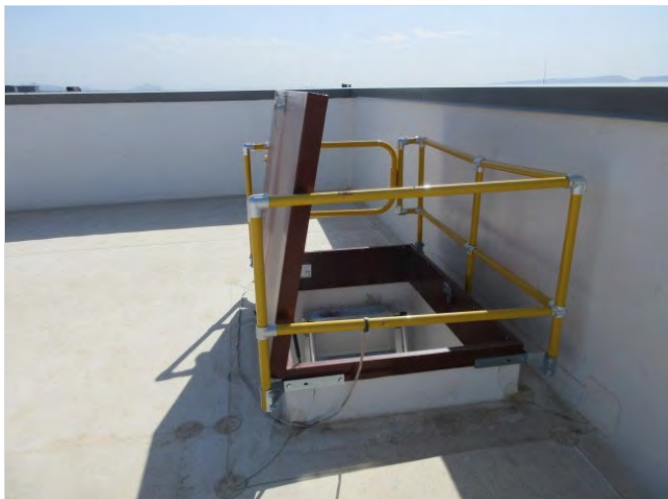
85. Roof access hatch

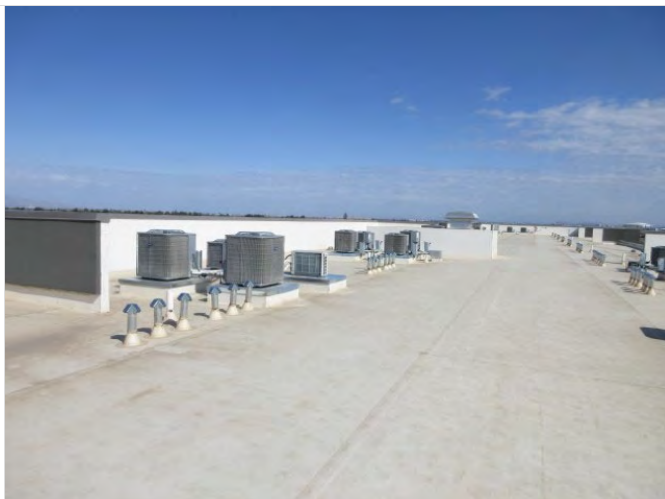
86. TPO roof membrane

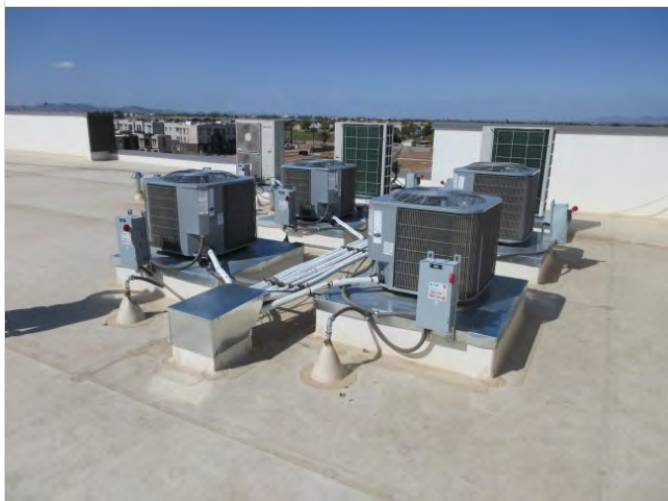
87. Rooftop mounted HVAC equipment

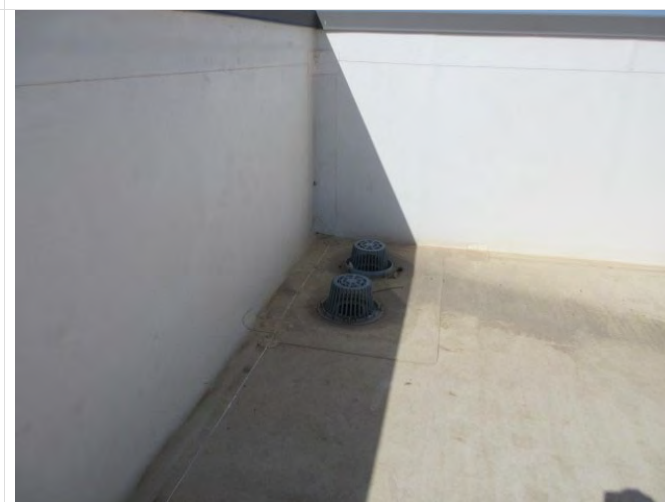
90. Roof drains (primary and secondary)

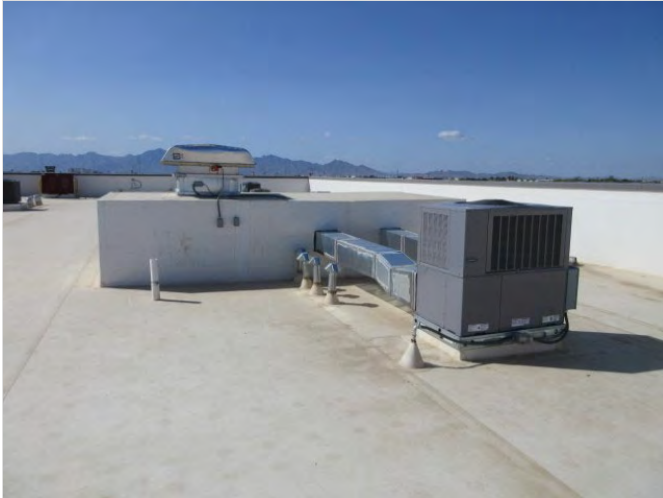
91. Elevator shaft package unit

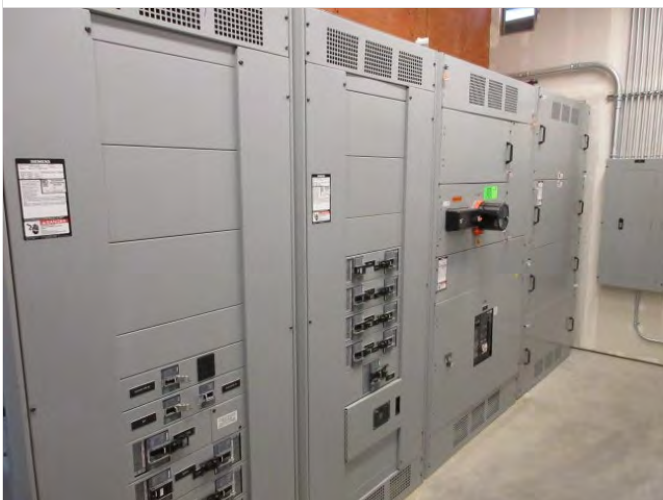
95. Main electrical switch

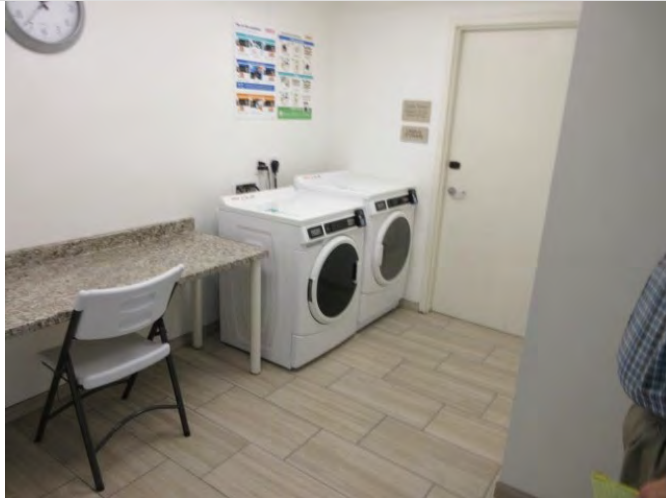
97. Guest laundry room

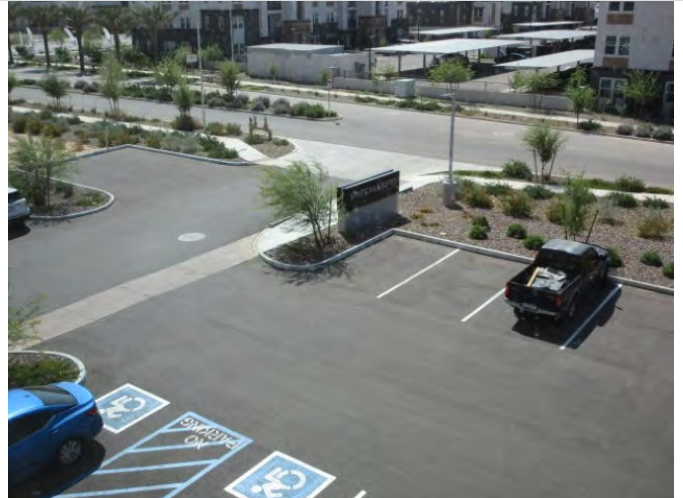
98. Surface parking adjacent to south elevation

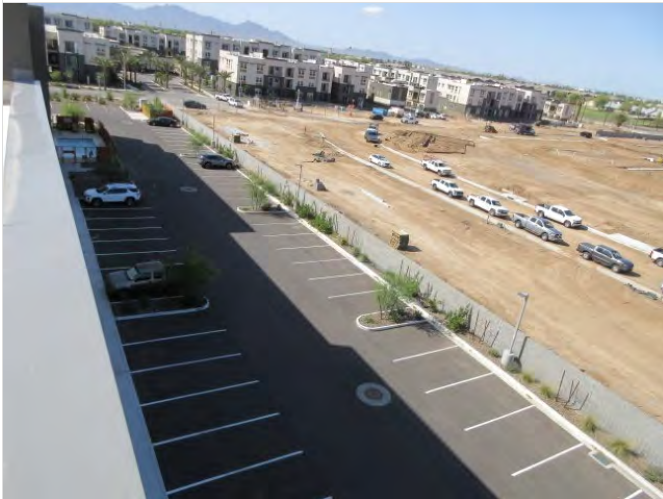
99. Surface parking adjacent to west elevation

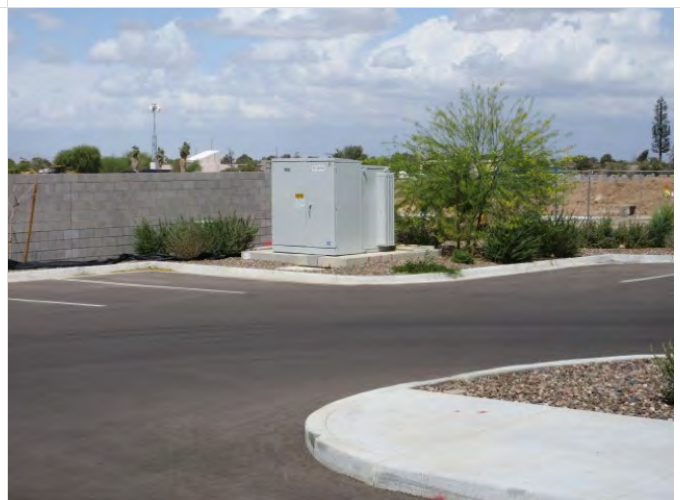
102. Pad-mounted transformer at northwest corner of property
